EXTENDING THE LIFE OF SECONDARY SERVICE CABLE THROUGH SILICONE GEL-INJECTION

Written by: James Steele, Director of Engineering; David Busby, PhD, Polymer Chemist; & Nathan Laurie, Field Sales Engineer

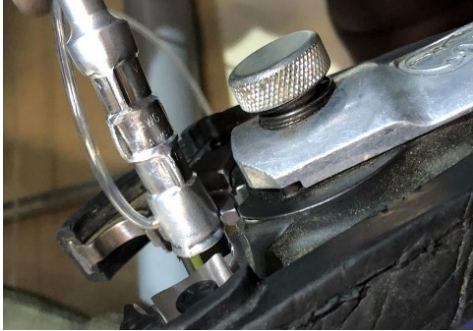
Fig. 4. Injection connectors are installed at each cable end to create a fluid access point for injecting silicone gel into the cable's conductor.

Injection connectors are proprietary devices installed at the cable ends (Figure 4). They provide controlled fluid access to the conductor while creating the electrical connection that joins the cable's conductor to the secondary buss. At the meter, the injection connectors are reconnected to the supply side of the of the buss (Figure 5). The flexible tubes from the injection connectors are routed to the collection tank, and the meter is reassembled and returned to service. At the transformer, the flexible tubes are routed to the pump that makes up the fluid delivery system discussed in the next section.

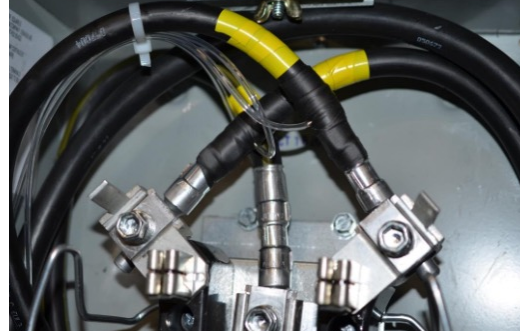
Fig. 5. Injection connectors installed in a residential 200A meterbox. Tubes are routed to the temporary collection tank.
